**BASIC IMAGERY
INTERPRETATION
REPORT**

**PETROVKA NAVAL BASE AND SHIPYARD
(SHIPYARD ACTIVITIES, JANUARY-MARCH 1971)**

RCA-09/0050/71

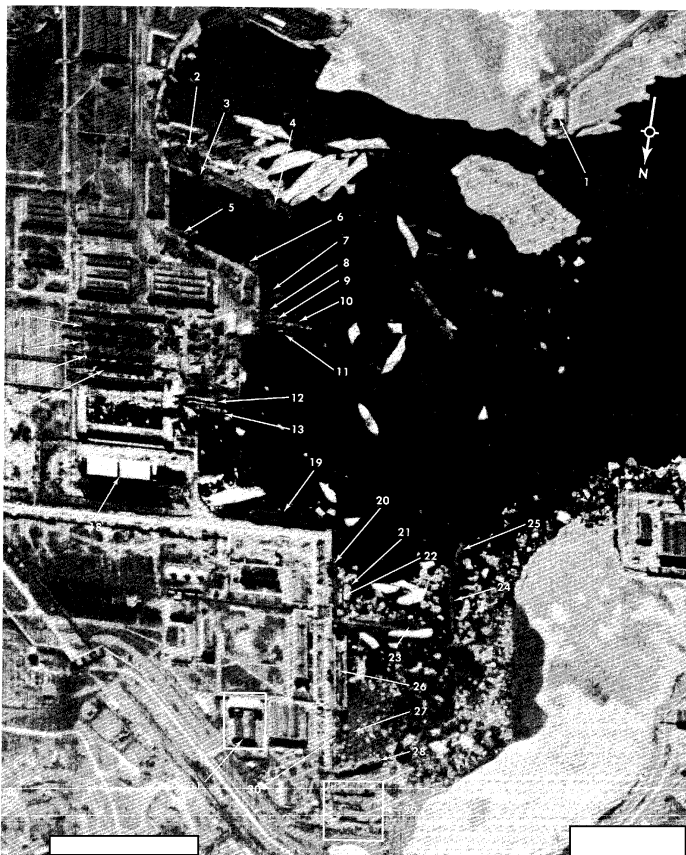
FIGURE 2. PETROVKA NAVAL BASE AND SHIPYARD, USSR,

5. By [] the Y SSBN had been removed from the dock and replaced by an unidentified large submarine. On that date, a Y SSBN being assisted by a tug was observed in the bay (Figure 2).

9. Construction continued on the new building in the fitting-out and repair yard. Progress on this structure has been slow. The overall appearance of the building remained unchanged during the reporting period (Figure 2, item 31).

Item	Description
1	Large building under construction on artificial island
2	Floating crane
3	Petrovka B YRSN
4	Probable support barge
5	Unidentified auxiliary
6	Probable floating crane
7	Probable floating crane
8	Unidentified small auxiliary
9	2 SO-1 SC
10	202-A AR
11	YFB
12	2 probable support barges
13	Probable AOL
14	E-II SSGN on repairway 4
15	N SSGN on repairway 3
16	E-I SSGN/SSGN on repairway 2
17	E-II SSGN on repairway 1
18	Repairway shed under construction
19	ARD(T) No 2 transporter dock (unoccupied)
20	Unidentified large submarine
21	Zeya YRSN
22	Rectangular support barge
23	Unidentified auxiliary
24	Y SSEN
25	Probable ATA/ATR
26	Unidentified large submarine in ARD(T) No 1 transporter dock
27	Petrovka A AR
28	202-A AR
29	Barges
30	PM-124 YRSN
31	Building under construction in fitting-out and repair yard
